Haley's Run Restoration Report

December 31, 2011

**Lockheed Martin
Haley's Run Restoration Report**

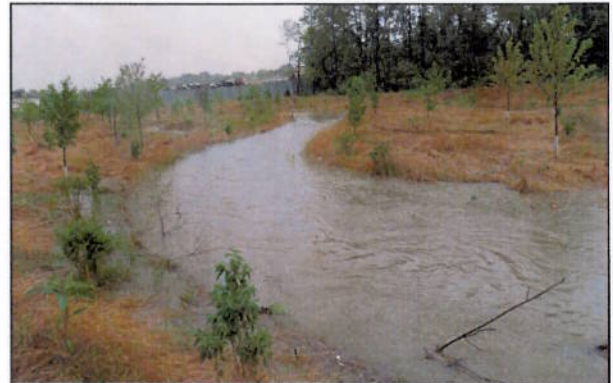
Figure 1. Haley's Flood Stage

To date, the restored stream is functioning very well. The current year has had record precipitation events, and the channel and banks have demonstrated exceptional stability throughout different stages of channel maturity (i.e., vegetation growth). The erosion fabric and grass seed mix has performed well and minimized any erosion. Deposition has occurred along inside meander bends, maintaining point bars, and pools have maintained their depths. More importantly, floodwaters are able to access the floodplain which is evident by Figure 1.

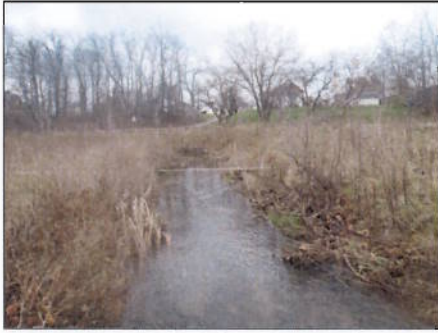
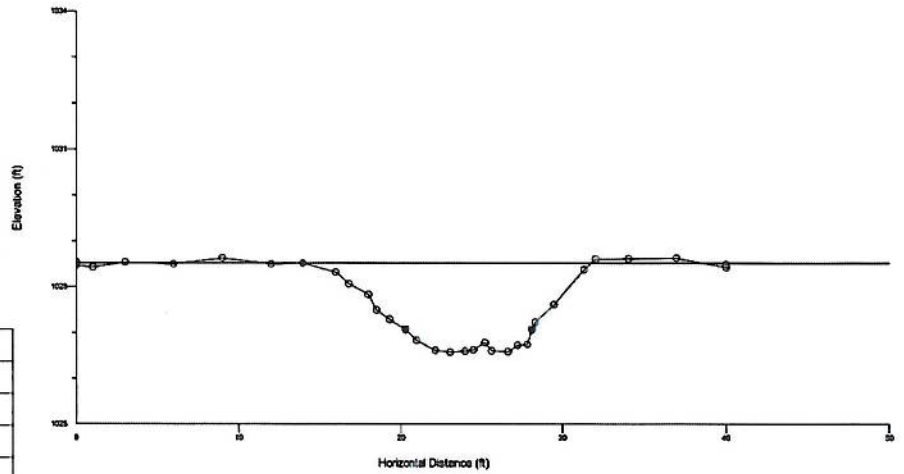
Figure 2. Cross Section Station 17+25 Riffle

Variable	Value
Bankfull Width	15.8 ft
Bankfull mean depth	1.35 ft
Width/Depth Ratio	12
Cross Sectional Area	21.4 sq ft.

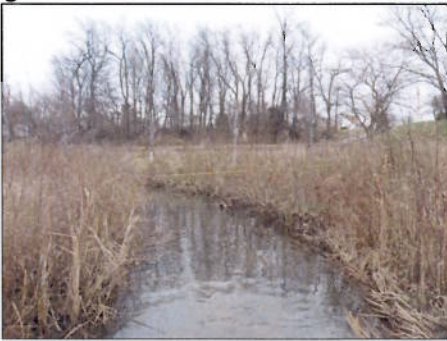
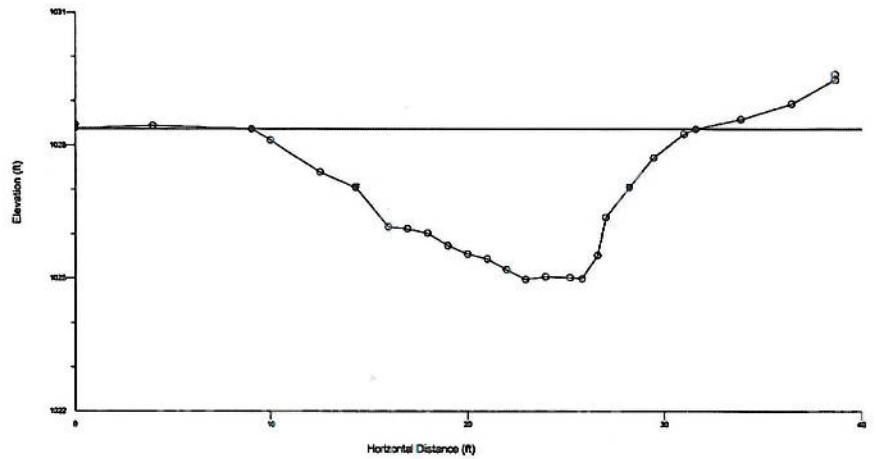
Figure 3. Cross Section Station 16+00 Pool

Variable	Value
Bankfull Width	24.9 ft
Bankfull mean depth	2.03 ft
Width/Depth Ratio	12.25
Cross Sectional Area	50.5 sq ft.

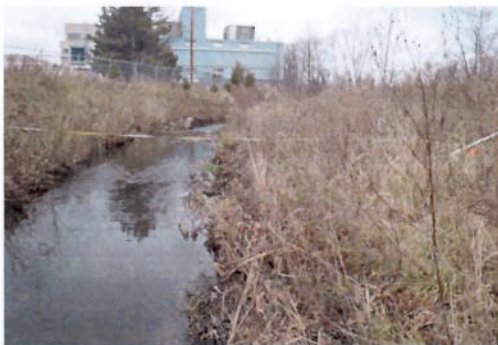
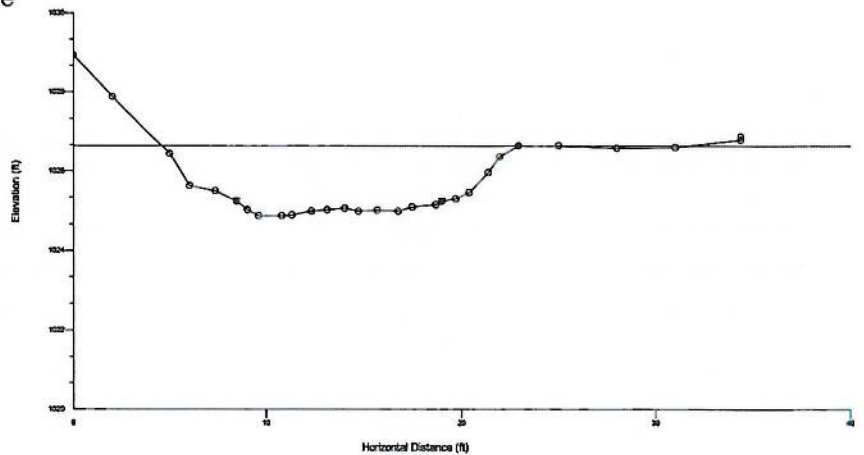
Figure 4. Cross Section Station 11+50 Riffle

Variable	Value
Bankfull Width	18.4 ft
Bankfull mean depth	1.3 ft
Width/Depth Ratio	14.2
Cross Sectional Area	24.0 sq ft.

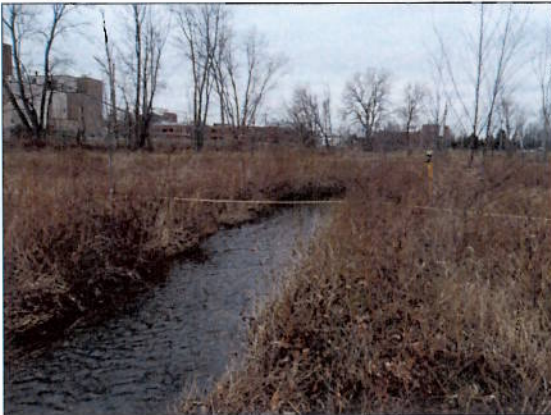
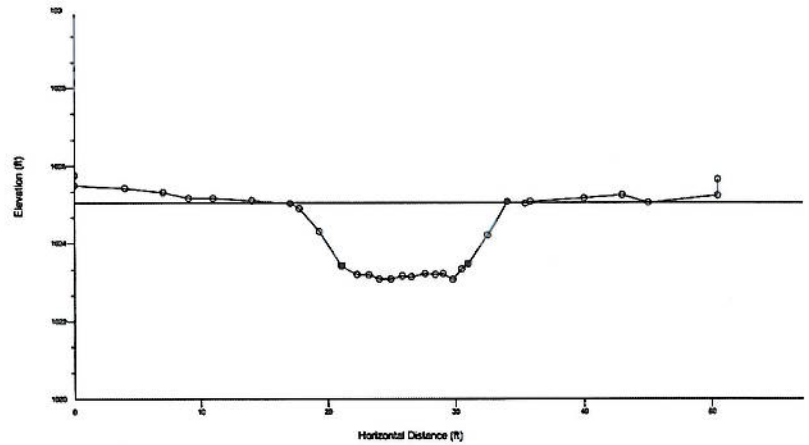
Figure 5. Cross Section Station 6+75 Riffle

Variable	Value
Bankfull Width	18.75 ft
Bankfull mean depth	1.27 ft
Width/Depth Ratio	14.75
Cross Sectional Area	23.8 sq ft.

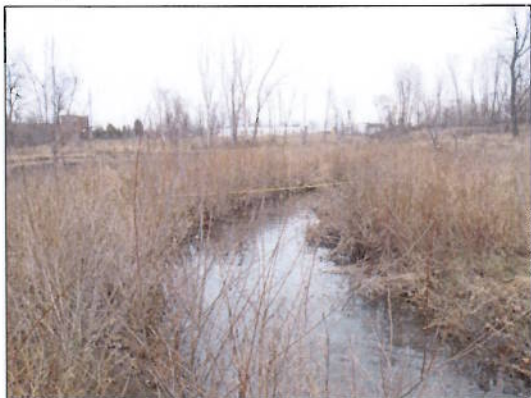
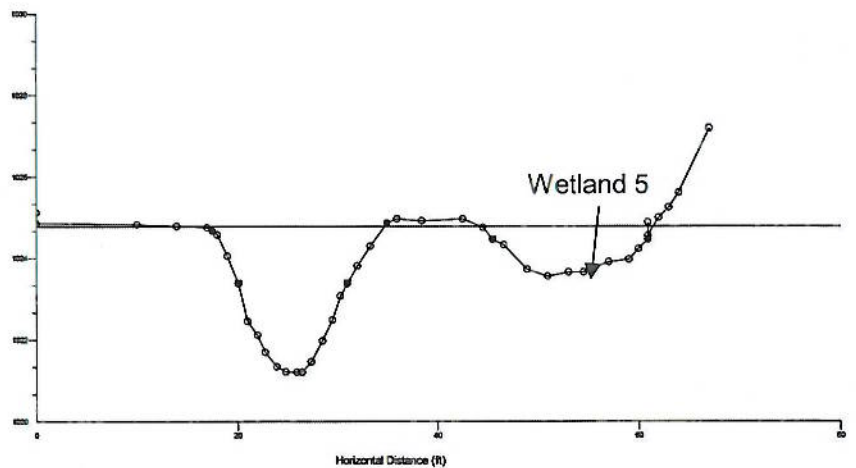
Figure 6. Cross Section Station 6+25 Pool

Variable	Value
Bankfull Width	19.7ft
Bankfull mean depth	1.78ft
Width/Depth Ratio	11.08
Cross Sectional Area	35.1 sq ft.

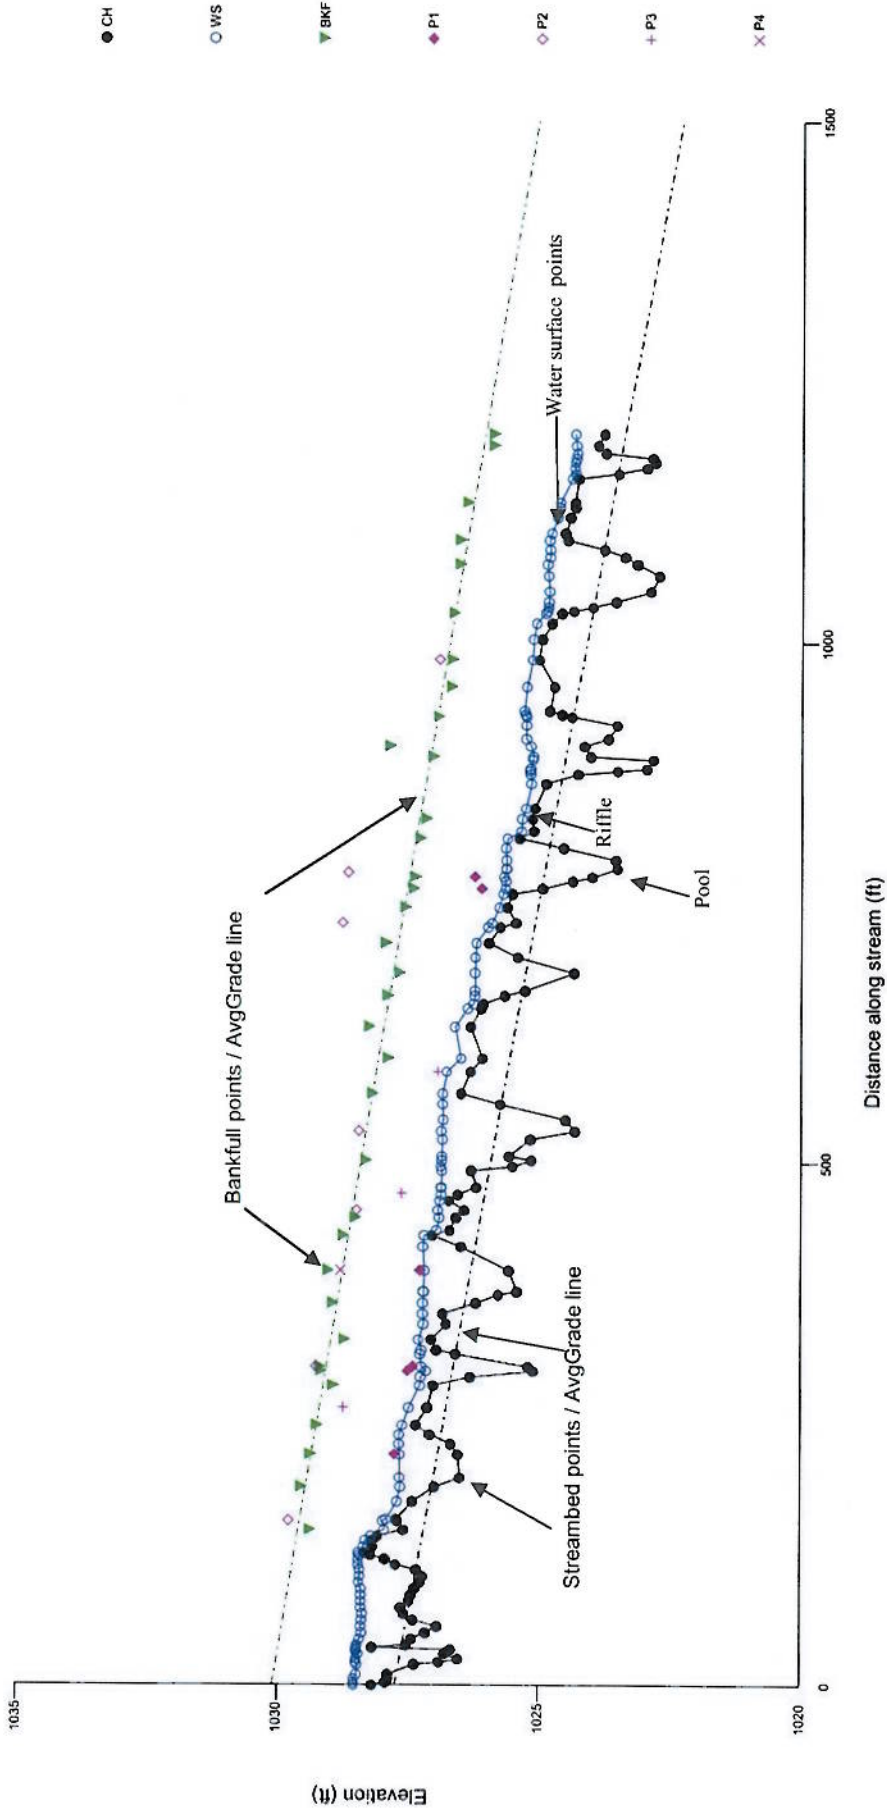
Figure 7. Haley's Run Longitudinal Profile Station 0+00-12+00

The stream bed profile was constructed as per plan with only minor horizontal shifts in the start or end of a feature. No riffles/pools were eliminated or significantly altered from the design plan. The profile also indicates that the average bankfull slope 0.0033 ft was achieved with bank construction and floodplain grading. Some profile adjustment was observed at the most upstream reach of the project area. This adjustment was limited to deposition in the pool immediately downstream of the Triplett Rd culvert, and did not adversely affect the project area downstream.

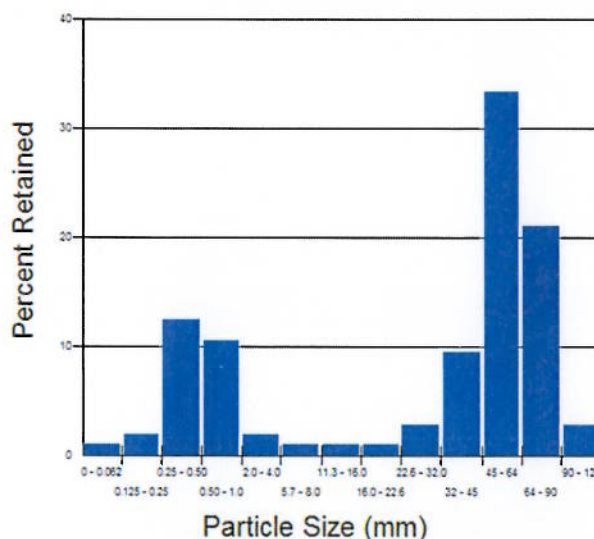
Figure 10. Cobble/Gravel Distribution

The results (Figure 10) indicate a distinct cohort of gravel/cobble material and sand component in the installed top layer of the substrate. The gap in the distribution relates to fine gravel (2.0-4.0 mm) and medium gravel (14.0-26.0 mm) that is anticipated to arrive from sediment transport upstream. This is based on observations of the existing channel and of newly deposited material below the Triplett Rd culvert. The installed top layer of cobble/gravel material was intentionally biased towards larger particle sizes that would not be delivered from upstream bedload.

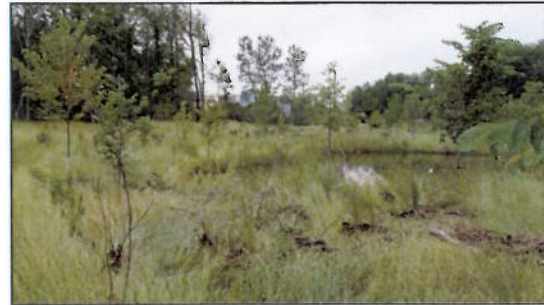
Figure 11. Flood Debris at inlet

Wetland 1- Is a 0.045-ac riverine wetland constructed along the original alignment of Haley's Ditch. Floodwaters access this wetland on a regular basis evident by flood debris (Figure 11). Furthermore, the wetland has a groundwater source that maintains a fairly constant water level throughout the majority of the year (Figure 12). Because of this, the wetland community associated with this area will be slightly different from the seasonally inundated wetlands that have a more fluctuating hydrologic regime. Overall, this is a positive outcome and adds more diversity to the type of wetland habitat restored with the project.

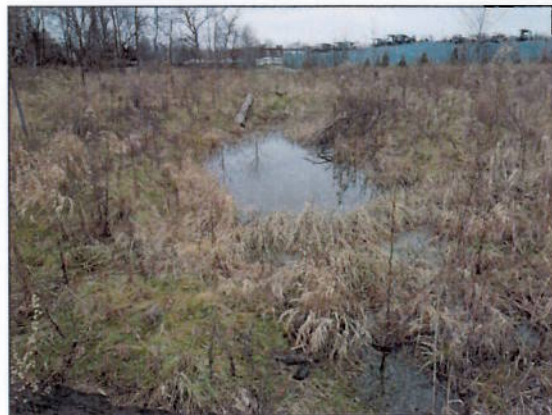
Figure 13. Wetland 2

Wetland 2- Is a 0.012-ac riverine oxbow wetland constructed in the South zone also on the previous Haley's ditch alignment (Figure 13). However, this wetland does not have the groundwater input seen in Wetland 1.

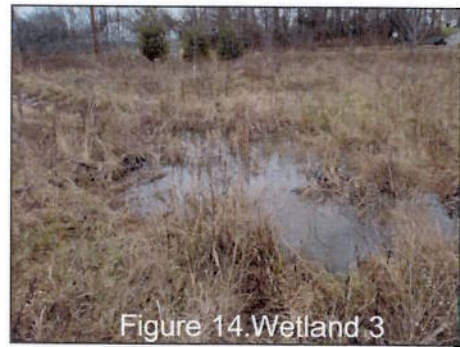
Figure 14. Wetland 3

Wetland 3 is a riverine 0.017-ac oxbow wetland constructed within the south zone western expansion area. This wetland receives surface water runoff from the LKQ facility. A small intermittent stream with a series of step-pools was constructed at a grade of approximately 10% to convey water from the upper slope to the wetland area. The outlet of this wetland is another small intermittent stream approximately 80 ft in length that confluences with the main channel at the end of the South zone (~Station 16+50).

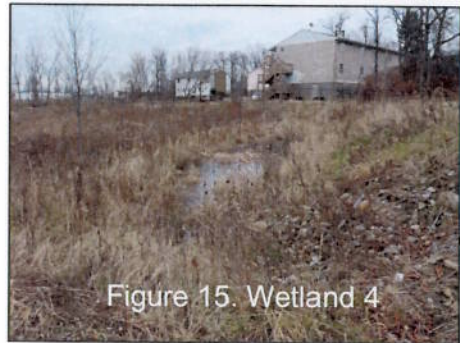
Figure 15. Wetland 4

Wetland 4 is a 0.027-ac riverine oxbow wetland that was added during the restoration construction. Beside floodwaters, this wetland primarily intercepts surface runoff from Landon Street and provides dissipation for the drainage culvert crossing under the walking trail.

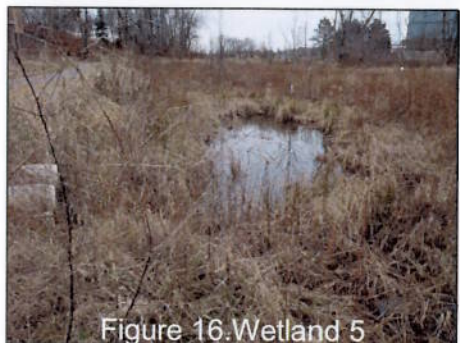
Figure 16. Wetland 5

Wetland 5 is a 0.017-ac river oxbow wetland that is positioned at the base of the walking trail near the end of Hobart Street. A drainage culvert under the walking trail intercepts drainage coming off Hobart Street. Prior to this project, drainage would discharge almost directly to Haley's Ditch.

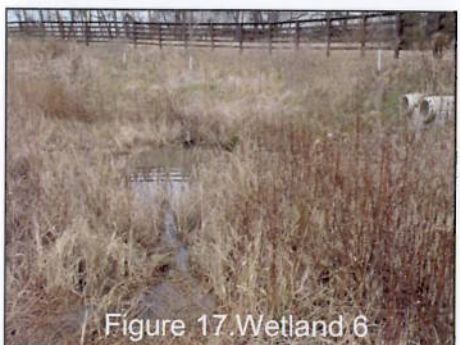
Figure 17. Wetland 6

Wetland 6 is a 0.018-ac riverine oxbow wetland that is adjacent to the walking trail. A drainage culvert discharges to the wetland but drains only a small area and will ultimately rely on hydrology primarily from overbank flows and precipitation.

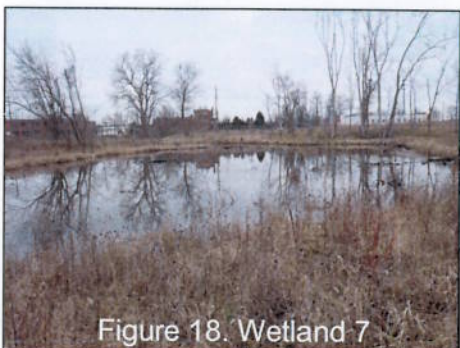
Figure 18. Wetland 7

Wetland 7 is a 0.90-ac riverine wetland that occupies the majority of the western portion of the restoration project in the North zone. This wetland has multiple inlets where floodwaters can access the area. Observations throughout the year suggest that approximately 0.5 inches of rainfall begins to supply water from Haley's Run. A large part of this wetland has remained inundated throughout the year. The average depth in the wetland is approximately 1 ft with a maximum depth just over 2 ft.
