Haley's Run Restoration Report

December 31, 2011

**Lockheed Martin
Haley's Run Restoration Report**

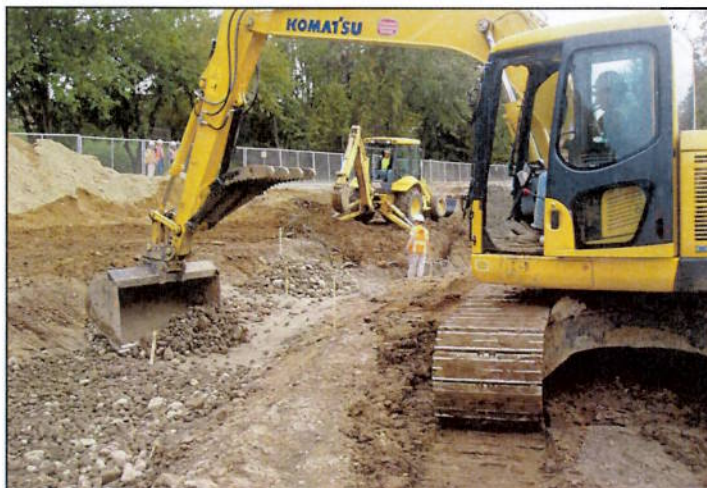
Figure 9. Substrate Installation

Cobble/gravel material was shaped and compacted in place with an excavator bucket (Figure 9). The particle distribution sampled on 10/16/09 (Table 2) shows the gradation of cobble/gravel material that was typically installed to finish grade. This distribution is based on a 105 particle sample.

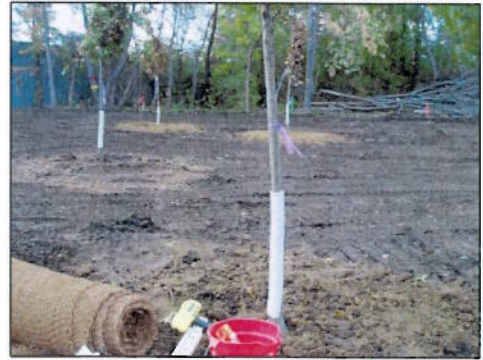
Figure 19. Installed Tree

A majority of the trees were installed with the assistance of a machine powered 3 ft auger. Holes were drilled to a depth approximately 0.5-1.0ft greater than root ball depth. Width of the hole drilled was expanded to at least 2X root ball width. Prior to drilling the hole the topsoil was preserved to one side of the hole to allow for use as backfill around the rootball. The hole was backfilled to the appropriate depth such that the top of the rootball was either flush or slightly lower than the surrounding finish grade. Excess material was used to create a water retention ring around the tree. Trees were watered to remove air spaces in the newly backfilled dirt (Figure 19).

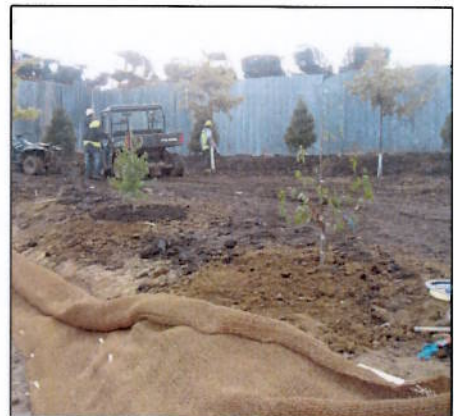
Figure 20. Installed Shrub

Shrubs were installed into hand dug holes. Topsoil was first preserved to one side of the hole. The hole was expanded to at least 2 times the container size and 0.25 to 0.5 ft greater in depth. Shrubs were carefully loosened from the pot and roots massaged from the root bound condition and placed into the hole flush or slightly below the surround finish grade. Shrubs were watered to remove air spaces in the newly backfilled dirt (Figure 20).

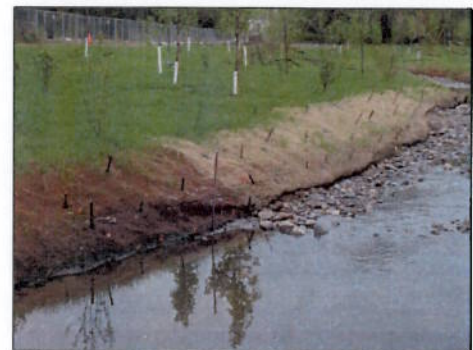
Figure 21. Live Stake Installed

Fast growing species such as willow and silky dogwood were focused along the stream banks in the form of live cuttings for bank stability and habitat (Figure 21). A total of 1,300 live cuttings were harvested (1,000) from northeast Ohio and purchased (300) from Ernst Seeds in Meadville PA. Live cuttings must be installed during the dormant season or early spring, therefore cuttings were installed in March and April. Cuttings were installed on approximately 3-5 ft centers along both banks of 1,200 ft of channel of the South and Middle zone completed in the Fall of 2009. A limited number of live stakes were installed in the North zone along the first meander bend downstream of Landon Street corner (~Station 11+00).

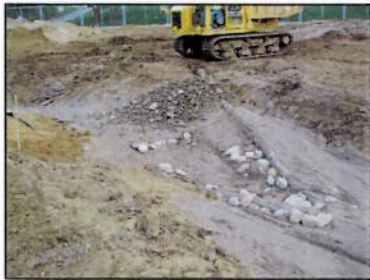
Figure 22. Log Vane

Woody material is an important component of headwater stream ecosystems and therefore woody debris was installed to form several different types of habitat that can be described as log-vanes, brush layering and log revetments (Figures 22-24). Thirteen woody habitat structures were installed throughout the project length. Specific woody debris locations, alignment, type and size was designed in the field at the discretion of the restoration biologist due to the variability of each location and source of wood. Installation of these structures generally occurred before finish grade. This approach allows logs to be buried into the bank, anchored with boulders and/or held into place with wooden "pins" that are essentially 3-5 inch diameter branches cut to a point. The length and diameter of the woody material comprising the habitat structure generally ranged from 10-20 feet in length and a diameter of 6-12 inches. All structures were installed at low angles, shallow slopes 2-5% and minimal protrusion heights to minimize risk with the structure relating to scour and flow affects. One structure at the beginning of the straight section in the North zone (just upstream of the Seiberling culvert) was a

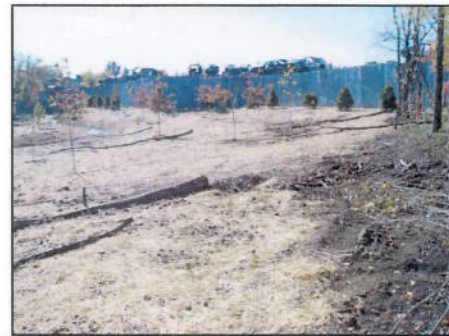
Figure 25. Deadfall Placement

Following topsoil placement, woody debris and logs were placed at locations in the floodplain and wetlands. The deadfall was generally placed at an angle with the flow of water. The deadfall provides additional habitat for wildlife and mimics the natural conditions of a wooded corridor and floodplain. Figure 25 provides an example of the amount and appearance of the deadfall prior to mature grass growth.
